Service Bulletin

Bulletin No: 01-03A

Product Line: ATV

Subject: Clutch Plenum Vent Boot

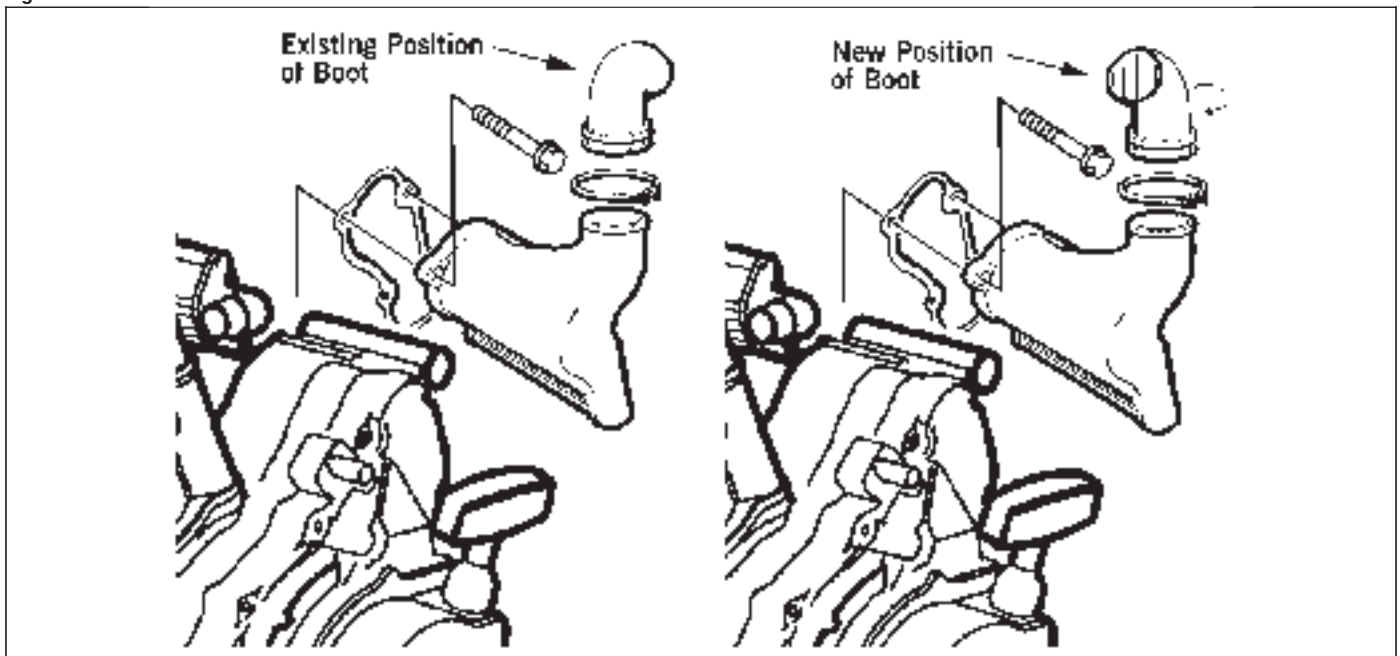
Fig. 1

Condition: It has been determined that when the affected ATV's are ridden through shallow water at moderate to high speeds, the rear tires may cause water to enter the rear clutch plenum vent boot and then flow downward into the clutch housing.

Solution: Loosen the clamp securing the existing clutch plenum vent boot; then rotate the boot until the open end of the boot faces forward. See Fig. 1. Secure the boot with the existing clamp.
