# Service Bulletin

**Bulletin No:** 2005-1-08

**Subject:** Possible Taillight Wiring Damage

All 2005 M-Series Snowmobiles

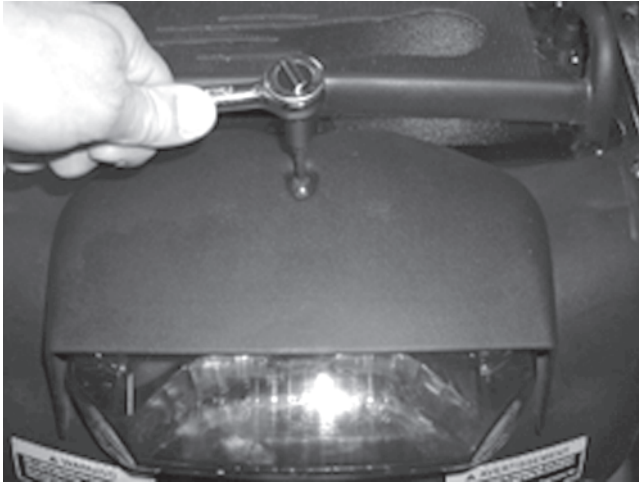
Fig. 1

1. Remove the torx-head machine screw securing the taillight mounting housing to the tunnel/rear heat exchanger. See Fig. 1.

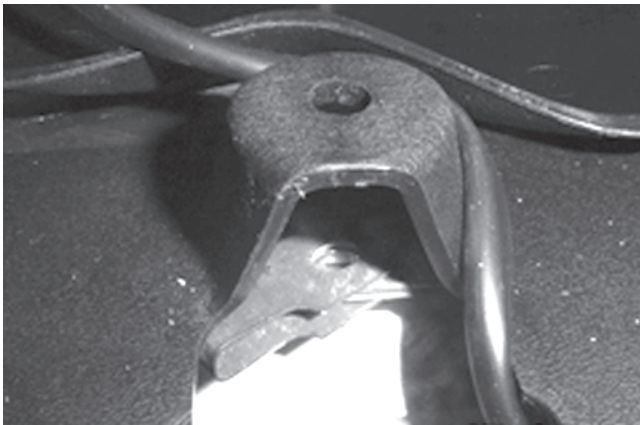
4. Secure the outer protective tubing using electrical tape.
5. Using a needle-nose pliers, remove the existing speed nut. See Fig. 2 for identification and location of existing speed nut.

6. Install new Speed Nut (p/n 1623-487).
7. Install the taillight bulb assembly into the taillight housing; then properly position the taillight housing and secure with existing torx-head machine screw.
