SERVICE

11
		B0200049

SB, 325 HS 75, 325 HS 99, 326 HS 75, Collector, 2002-06

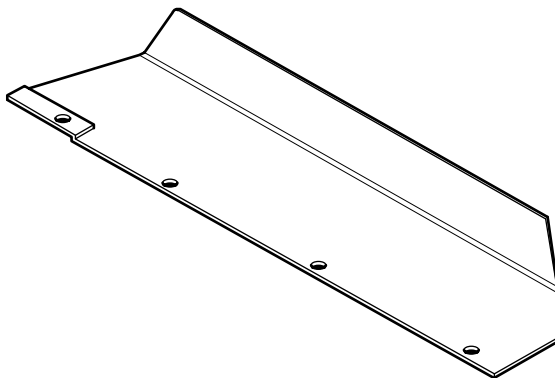
New version

The front edge of the collector has been modified and it now has round mounting holes. The part number is unchanged.

The cutter bar has nuts with integral washers, and longer screws to allow the collector to be attached more securely.

The nuts with integral washers have a locking action that reduces the risk of them working loose as a result of vibration. The tightening torque during assembly has also been increased from 6 to 11 Nm.

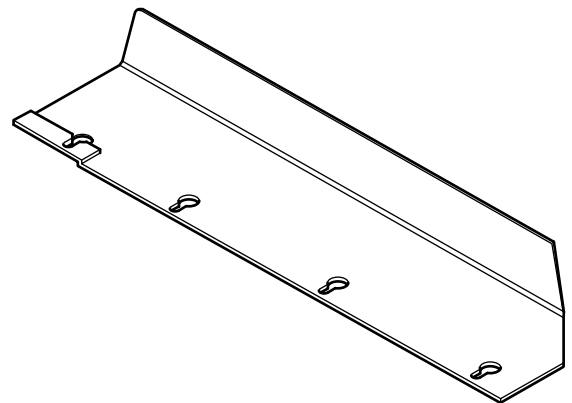
Previous version

There have been cases where the collector has cracked as a result of starting the hedge trimmer incorrectly or vibration from the cutter bar. A number of modifications have been made to rectify this problem.
