**Service
Bulletin**

**B0303010
2003-6**

Subject: Gen II and BAM Deck Belt Adjustments

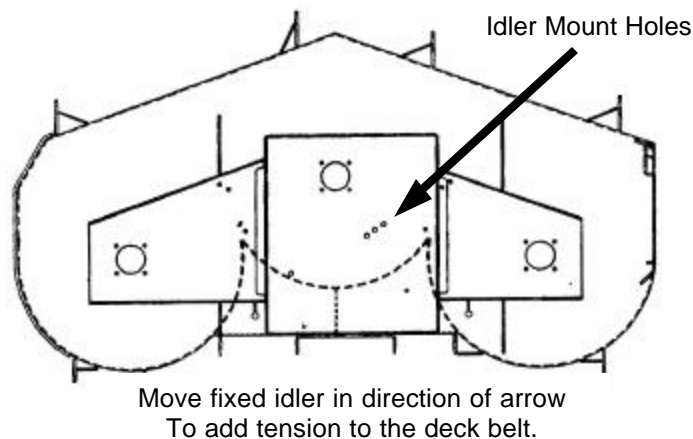
Decks used on the Gen II and BAM allow for belt adjustment. Belt adjustment will reduce belt vibrating and bouncing concerns.

The thinner fixed idler on the mower deck, part number 539 103257, can be adjusted to add tension to the deck belt to eliminate belt bounce. This idler mounts thru the deck usually in the forward most or center of three hole locations illustrated below.

To add tension, remove the deck belt; remove the thin fixed idler, and move it left and rearward by one hole location. Reinstall the mower deck belt.
