Service Bulletin	B0402003
	2004-02

Products: All LTH/ YTH/ & GTH Ride Mowers
with Serial Numbers Prior to 092203xxxxxxx

Subject: New Washer for Front Wheel Spindles

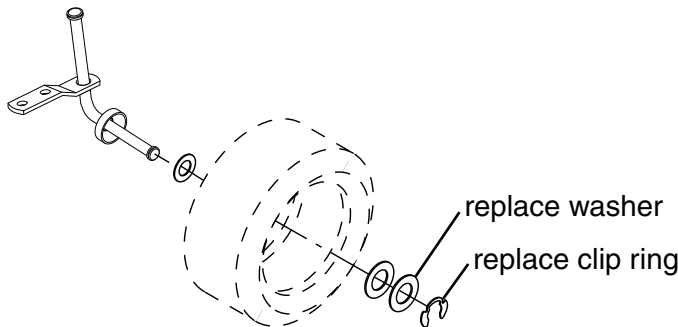
LTH /YTH Models

We have found that some original front wheel spindle washers on these units are too soft. This can cause the washer to become deformed due to rubbing from the clip ring and could eventually cause the clip ring to fall off.

If you encounter this problem on units in the field or if you have unsold inventory of the affected tractors, please replace the original outermost washer (silver finish) on both the left and right sides with the new hardened washer (black finish). As a precautionary measure, you should also replace the clip rings. Warranty time allowed for this update is 18 minutes.

NOTE: Only the clip rings and the outermost washers need to be replaced, reuse the other washers. See the assembly diagram shown below for the type of tractor you are working on.
