SERVICE 		1
		X 95.007-26

Model 250R/RX

Clutch

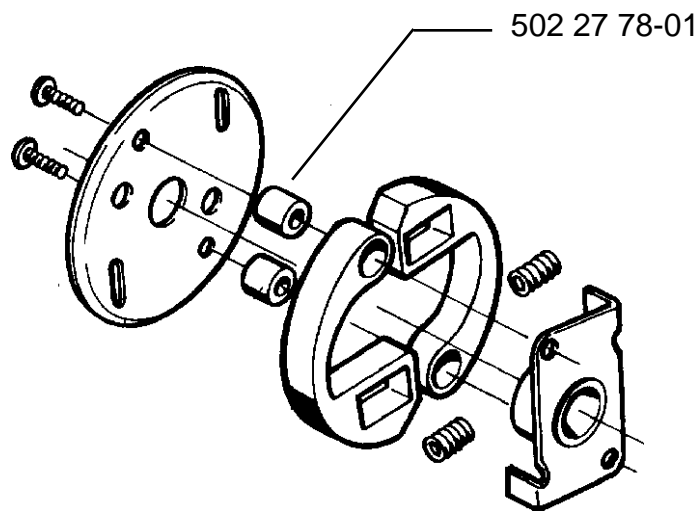
A degree of clutch slip is caused when the clutch is exposed to heavy loading, e.g. when using the trimmer head with heavy gauge cord. This creates heat which can damage the Teflon bushings on the clutch shoes. There is a new bushing now available as an option that is manufactured of bearing bronze and can withstand a higher temperature.

New Ref. No.	Description	Excl. Ref. No.	Remark
502 27 78-01	Bronze bushing	-
