## Service Bulletin, 145 BF, Throttle Cable, 1999-03

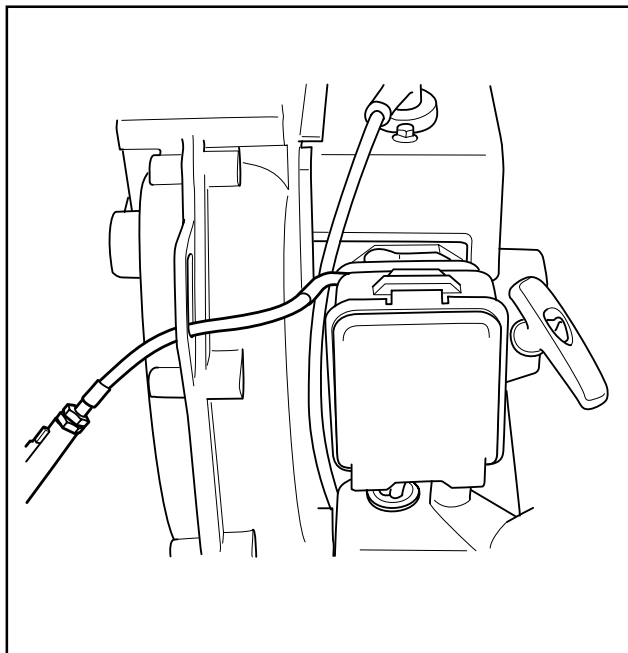
*Figure 1  
Earlier version*

On the earlier version, figure 1, the cable ran straight out from the side of the carburettor. On the revised version, figure 2, the cable runs straight down from the carburettor.

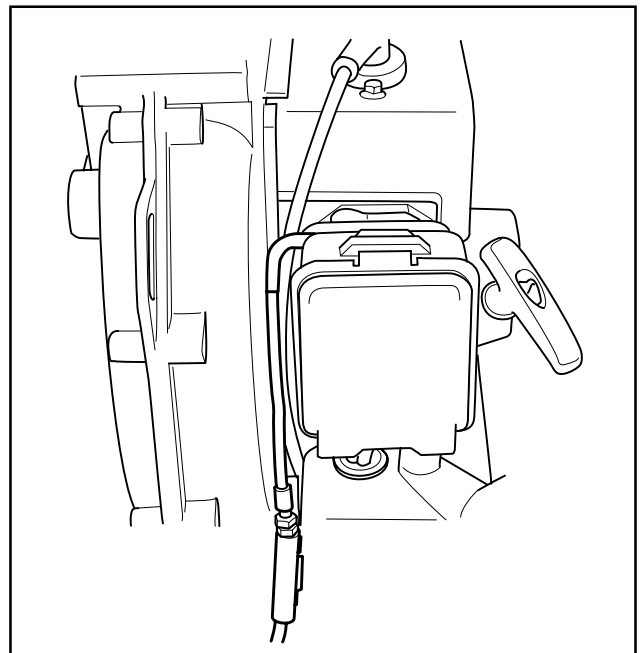
*Figure 2  
Current version*

In order to reduce the effort needed to operate the throttle trigger, the throttle cable has been re-routed. See figures 1 and 2. The new arrangement means that the throttle cable is slightly shorter. This change was introduced into production in October 1998.

Earlier machines can also be fitted with the shorter cable if the elbow sleeve nearest the carburettor is turned so that it points straight down. Figure 2.
