Service
Note

N0203017

Subject: Deck Belt Wear (fraying) from Frame Misalignment

Effected Model Numbers: All Commercial Walk Behind WHF "Quick Lift" Mowers

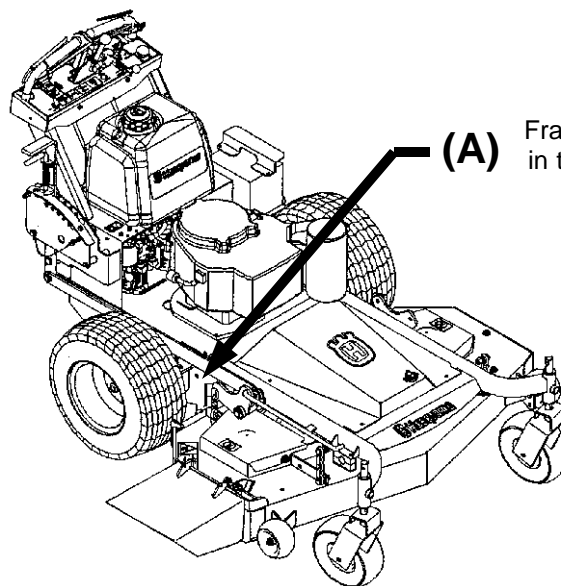
Front Frame to Engine Frame misalignment has created a concern that WHF mower deck belts are fraying and failing. This misalignment can occur because this area is shipped loose.

(A) Frames are fastened together in this location on both sides.

If belt fraying is an issue, loosen all eight (8) 7/16-14 x 1 bolts and lock nuts connecting the front frame to the engine frame. Using a level, align the frames at **(A)** in the illustration below to be straight with each other. Tighten these bolts to 30 to 40 ft. lbs. (40-54 N.m).
