SERVICE BULLETIN 117

SUBJECT: Hot Restart Difficulty and/or Hard Starting on Ariens Rotary Mowers

MODELS OR TYPES AFFECTED: TVS105-53038C, TVS105-53039C
TVS105-53038D, TVS105-53039D

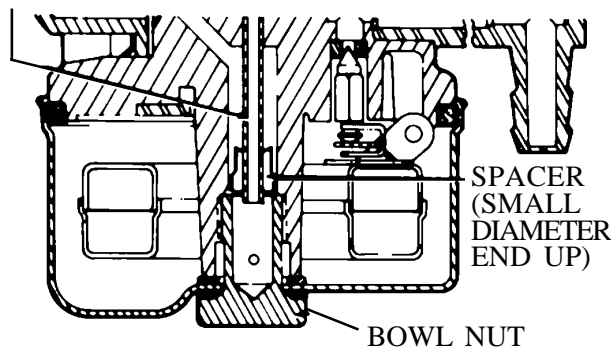
MAIN NOZZLE
TUBE

Field complaints of hard starting or restarting a warm engine on the subject engine models have been occasionally reported by the field organization. In order to eliminate these starting problems we recommend the installation of Tecumseh service kit, part number 730219, which consists of a carburetor fuel spacer and a new bowl nut. This kit can be obtained from your Tecumseh source of supply. Remove the old bowl nut (do not remove carburetor bowl or disturb bowl O ring), install the fuel spacer into the carburetor and install the new nut. Instructions below will also be furnished in the box with the parts.

- A. Disconnect spark plug wire.
- B. Drain fuel from fuel tank.
- C. Tip lawnmower on its side, carburetor side up.
- D. With a box end wrench, remove the original bowl nut & gasket. Install spacer per reverse illustration. Position original gasket on new bowl nut and install. Tighten bowl nut.
- E. Set mower up, fill fuel tank and connect spark plug wire.
