SERVICE
BULLETIN
122
INFORMATIONAL

SUBJECT: Recoil Starter Will Not Engage When Pulled

MODELS OR TYPES AFFECTED: Small Frame (3 thru 6 HP) Horizontal and Vertical Engines with DOM 7335 thru 8150

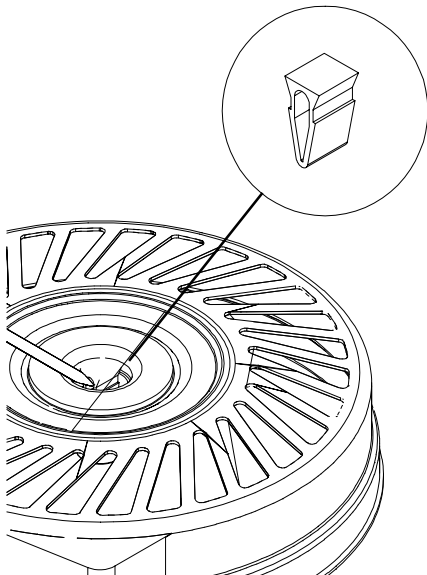
OLD

If you have experienced an occasion where the recoil starter will not engage when the rope is pulled, a simple repair may solve the problem. This repair will only affect starters that have the white plastic locking tab located in the top/center of the starter. The locking tab may be covered by a round protective decal or could be located in the recoil under a decorative cover. The decorative cover will have to be removed to allow for repair. However, it is not necessary to remove the recoil starter from the engine to make the repair.

To make the repair you need to remove the protective decal to expose the white plastic locking tab. Use a small flatblade screwdriver or needlenose pliers to pry up on the tab and remove it from the starter. Discard the old tab and replace it with a new metal locking tab part #590760, which also includes a new protective decal. Press the new metal locking tab down into the retainer until it snaps into place. Place the new protective decal over the tab hole to prevent any water or debris from entering the starter.
