SERVICE  
BULLETIN  
127  
INFORMATIONAL

**MODELS OR TYPES AFFECTED:** OHV 13.5HP – OHV 17.5HP

**SUBJECT:** Cracked Rocker-Arm Bearings

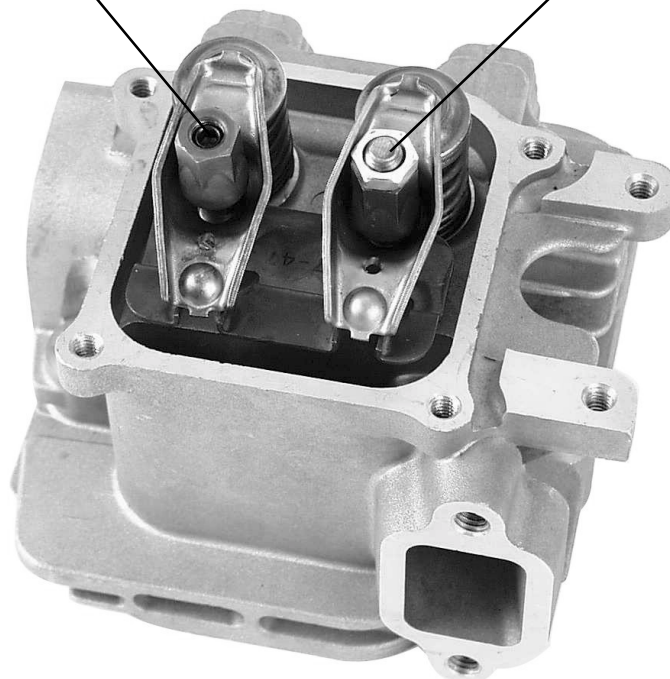
We have developed a new Rocker-Arm Bearing Kit part number **730636** to address field concerns of rocker-arm bearing breakage. This typically is caused by over-torquing the Allen lock screw during adjustments. The kit includes longer rocker arm studs, jam nuts to replace the Allen lock screws and new rocker-arm bearings.

To simply replace the cracked rocker-arm bearings and set screw could result in the same problem reoccurring. The **Rocker-Arm Bearing Kit** part number **730636** can be ordered from your normal source of supply.
