SERVICE
BULLETIN
128
INFORMATIONAL

ISSUED: December 2001
MODEL AFFECTED: OHSK70
SPECIFICATION NUMBER: 72523D
DOM's AFFECTED: 1221 THROUGH 1309

Simplicity Model: 755 Snowthrower
Simplicity Manufacturer Number: 1693983

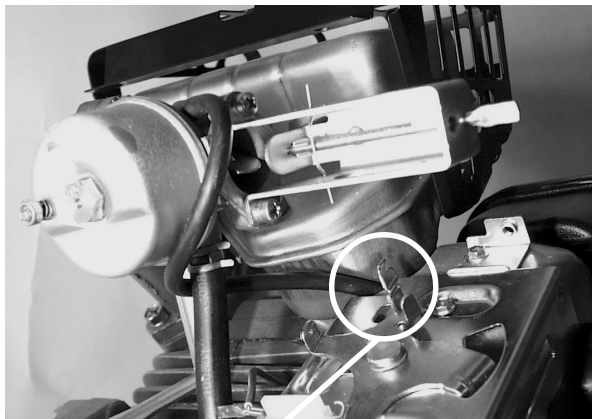
PHOTO 1

Photograph 1 shows the **INCORRECT** routing with the primer line pinched between the housing and muffler. If the engine is started with the line located in this position, the line will melt immediately on start-up causing the primer to no longer function, which results in hard starting.

INCORRECT

Prior to sale of any 2002 Simplicity model **1693983 755 snowthrower**, please inspect them for improper routing of the line as shown in photo 1. If the line is not properly located as shown in photo 2, use a blunt object or your hand to move the line to the correct location as shown. Also check that the line routing is behind and under the fuel line as shown.

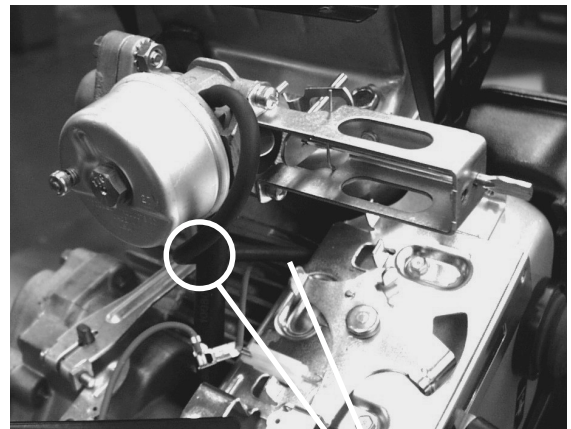
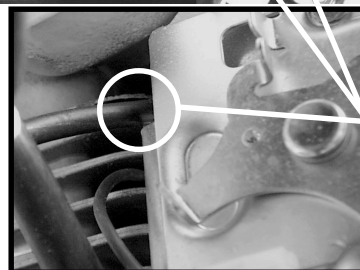
PHOTO 2

CORRECT
