**SERVICE  
BULLETIN  
130**

**SUBJECT:** Fuel Starvation, Vapor Locking on Stylized LH318SA & LH358SA

**MODELS OR TYPES AFFECTED:** Stylized LH318SA/LH358SA Snow King Engines Manufactured before D.O.M. 05220

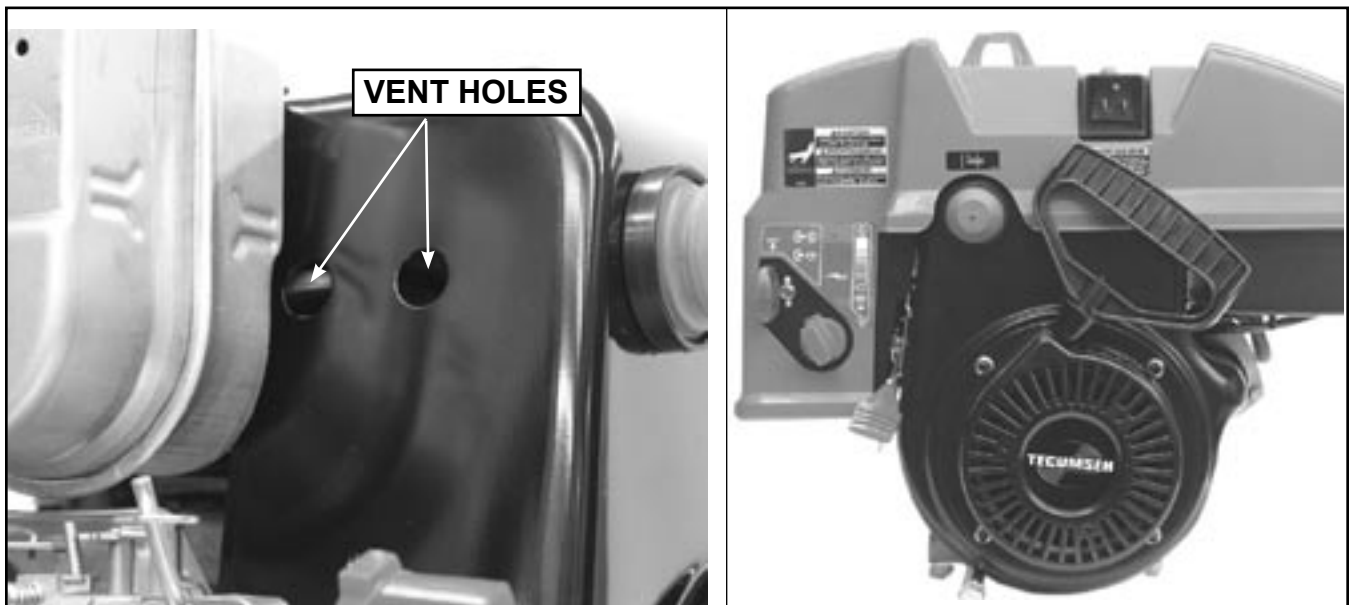
We have identified a concern with poor run quality under no load on the 2004/2005 stylized LH318/358SA (Snow King) engines. Testing by our engineering department has confirmed that increased carburetor air intake temperatures can occur with the use of some regional blends of fuel.

The new blower housing (**part number 37961**) has two vent holes added to the area just inside the heater box, which reduce the carburetor air intake temperatures.

If a unit with this additional stylized shrouding is brought in for service exhibiting the symptoms of fuel starvation, (after the engine has reached full operating temperature) the condition may be resolved by changing the blower housing.
