SERVICE
BULLETIN
406
4 CYCLE

SUBJECT: Smoking Out of Muffler on Initial Start Up

MODELS OR TYPES AFFECTED: VLV 50 through 66

SERIAL NO'S AFFECTED: 7002 through 7128

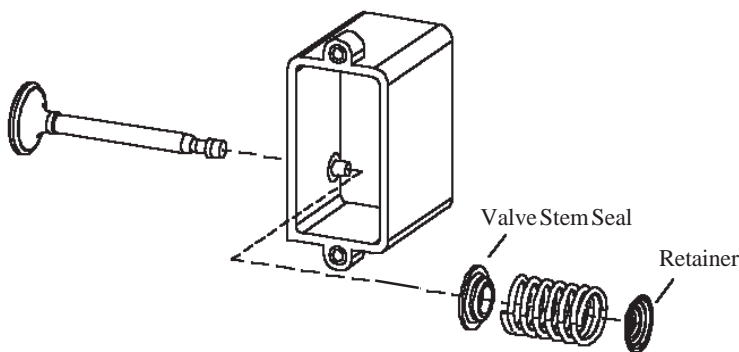
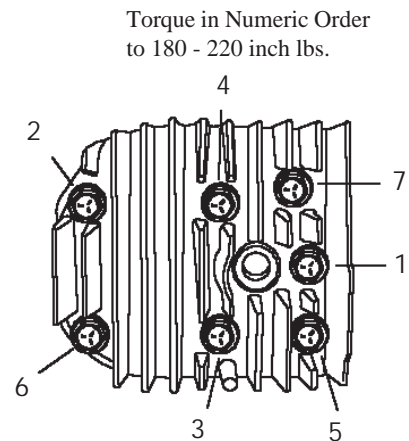
After investigation we have determined the cause of the smoking. This is the result of an irregular casting surface in the valve spring box, which does not allow proper seating of the seal allowing oil to pass.

1. Remove the muffler, cylinder head and valve box cover.
2. Remove the Intake valve spring, valve and seal.
3. Install the NEW valve stem seal part no. 40016A as shown (see illustration).
4. Replace the cylinder head gasket part no. 36061 and valve box cover gasket part no. 27234A.
5. Re-torque the cylinder head to 180-220 inch Lbs following the sequence below.
6. A kit containing all the above parts can be ordered under part no. **730617**.
