Service Advisory

ZT SERIES

W-135

Subject: **Bypass Rod (747-04217C)**

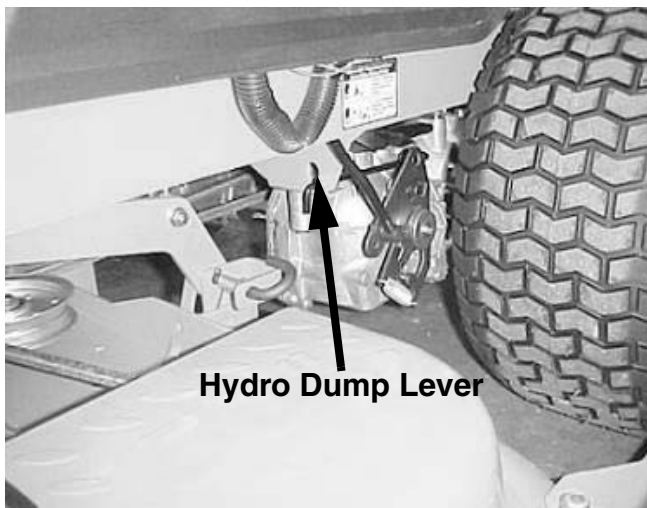
FIGURE 1.

PURPOSE: To bring attention to the hydro bypass rod not being able to be released / activated when the cutting deck is in the highest position.

Lower the cutting deck to the lowest position. Locate the hydro bypass rod located on the left side of the unit, the dump rod faces the front of the unit with the lever facing down as shown in Figure 1.
