Service Advisory

W-136

Models Affected: W 83MC (12AV83MC790)

Subject: **Variable Speed Control Lever (731-05388). FIX-AS-FAIL.**

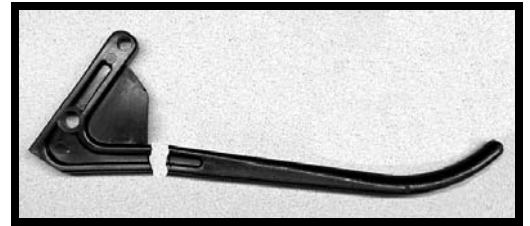
FIGURE 1

SYMPTOMS: There have been sporadic reports that the plastic self-propelled control lever, 731-05388 may be failing during use. See FIGURE 1. Failure can be the result of an improper curing process in combination with the lever's web configuration. In addition, the potential for failure may be increased as a result of the drive control cable being mis-routed around the metal stop bracket on the transmission. See FIGURES 2 and 3.

1. Place the mower on a level surface. Remove spark plug wire from the spark plug and ground to engine block.
2. Drain the fuel tank.
3. Disassemble the speed control housings and discard broken control lever. Do not reassemble at this time.
4. Turn the unit onto it's side so that the air cleaner is towards the sky.
5. Check the cable routing at the stop bracket on the transmission. FIGURE 2 shows the drive cable routed incorrectly. Correct by moving the cable onto the top side of the stop bracket. FIGURE 3 shows the drive cable routed correctly.

6. Install new lever 731-05388, and reassemble the speed control housings. Reinstall spark plug wire onto the spark plug. Fill unit with fuel and start to check for proper operation.
