Service Kit

753-05145

Subject: Hydro Drive Belt Tensioning Idler

Models Affected: 2005 Model Year Hydro Drive 611-619 and 811-819 Series Lawn and Garden Tractors

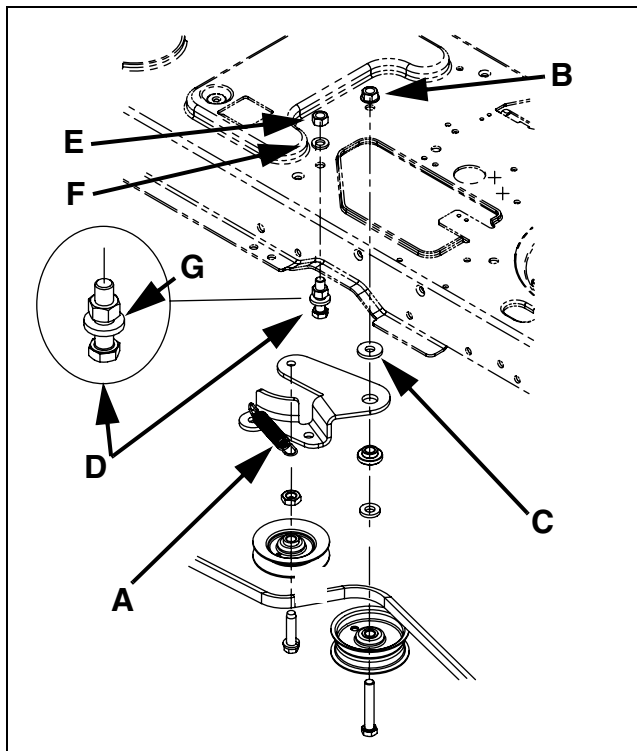
FIGURE 2

1. Under certain operating conditions, i.e. heavy loading on transmission drive, the hydrostatic transmission drive belt tensioning spring may unhook from its' bolt attachment point. This results in a loss of drive to the hydrostatic transmission. **Serial Number Range Affected: Units built between December 9, 2004 (Date Code "...L094H...") and June 21, 2005 (Date Code "...F215H...")**

2. If the tractor was built with a 736-0320 (1.38 O.D.) flat washer in the idler pivot hardware stack-up an idler rattle may be noticed during operation. **Serial Number Range Affected: Units built between December 9, 2004 (Date Code "...L094H...") and May 19, 2005 (Date Code "...E195H...")**

20. See Figure 2. Inspect spring attach bolt sub-assembly, "D", for a floating washer, "G", between the head of the bolt and the under the frame nut. If the washer is present, remove hex nut "E" and lock washer "F". Disassemble the bolt/nut/washer sub-assembly, "D" and remove the floating flat washer. Re-install the bolt sub-assembly as was originally installed less the floating flat washer.

17. Slip the drive belt off of the fixed idler (not shown) on the left underside side of the frame. Unhook the extension spring, "A", from its' attach point at the bolt sub-assembly, "D".
18. Remove the hex nut "B" and lower idler bracket assembly.

19. Discard flat washer "C" and install new Flat Washer 736-0258, Item 2, in its place. Re-install idler bracket assembly to frame.

26. Replace the existing extension spring 732-0429A with Extension Spring 732-04323A, Item 1. See Figure 2 Item "A". The spring **MUST** be hooked at the lowest point on bolt "D" (i.e. next to the head of the bolt). The orientation of the spring hooks relieves the twist in the spring when installed. The new spring also provides additional coil separation.

NOTE: If repairs were started at Step 26 there may be a floating flat washer on the spring attach point bolt "D". See Figure 2. The floating washer is not required with the new spring but can be left as is. However, the floating washer **MUST** be positioned between the spring hook and the frame.
