Service Advisory

W-153

Subject: **Grass build up between front transmission cover and deck. Fix-As-Fail.**

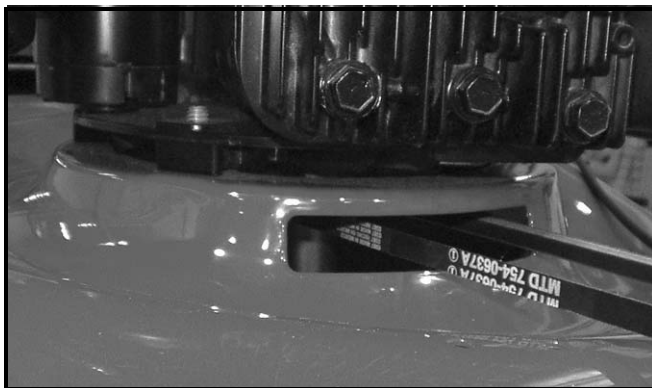
FIGURE 1

DISCUSSION: This service advisory is applicable to those 400 and 500 Series walk behind mower models where the engine mounts directly to the metal deck as shown in Figure 1.

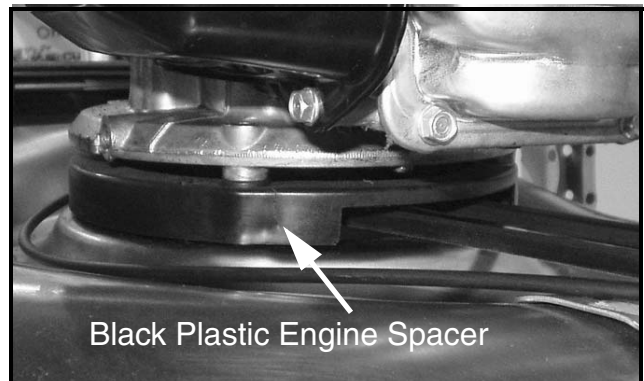
FIGURE 2

This service advisory is not applicable to those models with the black plastic spacer between the engine and metal deck, see Figure 2. There is no supplemental baffle for these models.
