Service Advisory

W-155

TRACTOR

Subject: A "ratcheting" sound is heard and felt in the steering wheel.

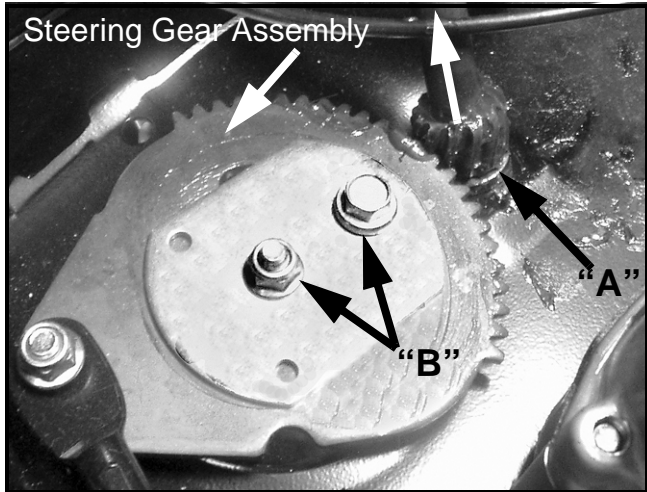
FIGURE 1

A.) The steering shaft is properly seated in the hex flange bushing in the frame and does not pull up and out of the hex flange bushing.

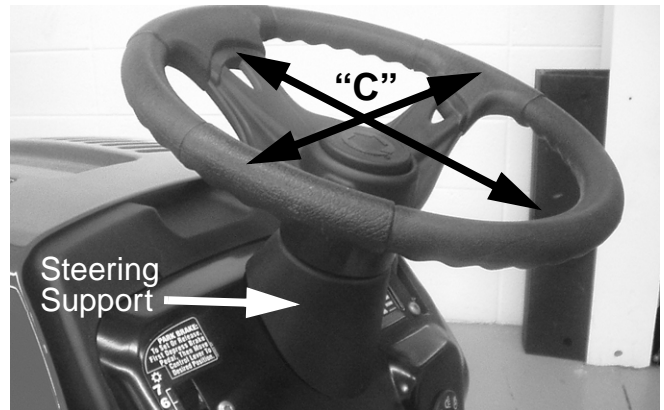
C.) Gently move the steering wheel forward and back and from side to side. If there is significant movement in the steering shaft **without** the plastic steering support moving, there is excess wear in the steering support and should it be replaced. See Figure 2.

D. Inspect the teeth on the steering gear assembly and on the steering shaft. If there is wear allowing the steering gears to skip a tooth when steering, install service kit **753-05746** (see attached instruction sheet).
