Service Bulletin

Product Line: Snowmobile

Bulletin No: 2003-1-13

Subject: Speedometer Cable Routing

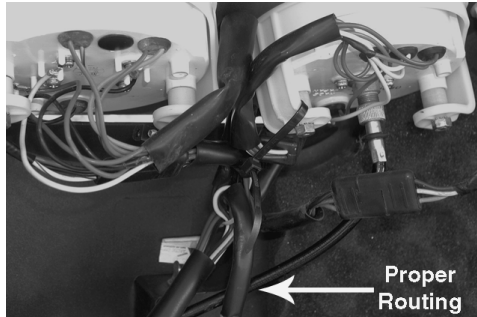
Condition: It has been determined that the speedometer cable on the affected models may come into contact with the top of the air silencer plenum causing possible damage to the cable.

Solution: Disconnect the speedometer cable; then reroute the cable behind the hood harness making sure the cable slack is pulled toward the gauge. Connect the speedometer cable. See Fig. 1 for proper routing.
