Service Bulletin

Bulletin No: 2003-1-17

Subject: Improper Gasline Hose Routing

Model: 2003 Mountain Cat 900 (159 in.)

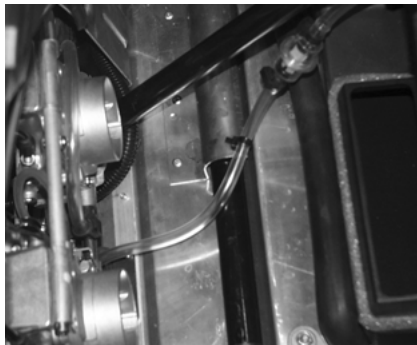
Condition: It has been determined that existing Gasline Hose (p/n 0610-016) between the gas tank and the fuel pump was incorrectly routed and secured to the driven shaft protector bracket. This incorrect positioning will cause the hose to wear against the bracket resulting in severe damage to the hose. See Fig. 1 for the improper routing and positioning of the hose.

Solution: Inspect all affected snowmobiles to determine if the gasline hose is improperly routed and secured to the driven shaft protector bracket.

■ **NOTE:** To obtain easy access to the gasline hose, it is recommended that the air silencer assembly be moved forward.

If the hose is improperly routed and secured (see Fig. 1), remove the gasline hose from the cable tie.

■ **NOTE:** When the hose is properly routed and not secured to the bracket, the hose should lie under the steering post and along side the air silencer assembly (not underneath).
