Service Bulletin

Product Line: Snowmobile

Bulletin No: 2003-1-30 (Condition A)
2003-1-31 (Condition B)

Subject: Coolant Drain Hose

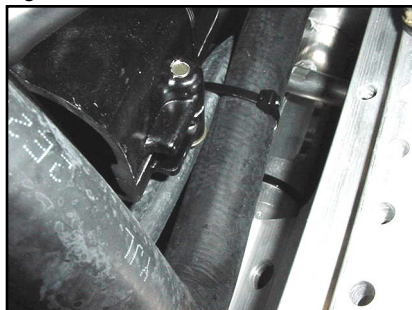
■ **NOTE:** The water pump-to-coolant reservoir hose is located directly above the coolant drain hose. See Fig. 1 for the proper location of the cable tie.

Solution A: Inspect the existing coolant drain hose on affected models. If the hose does not appear to be worn, move the hose upward away from the chassis and secure it to the water pump-to-coolant reservoir hose using a cable tie.

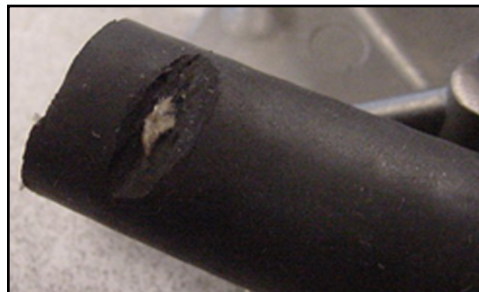
Condition B: It has been determined that the existing coolant drain hose on an affected model may come into contact with the chassis of the snowmobile causing the coolant drain hose to wear through. This condition will result in the loss of coolant and possible damage to the engine. See Fig. 2 for example of worn hose that needs to be replaced.

■ **NOTE: Fig. 2 illustrates a coolant drain hose that is worn to the cords and needs to be replaced.**

Solution B: Install Coolant Drain Hose Update Kit (p/n 0637-251).
