Important Safety Recall

Models Involved: GTH2550XPA
GTH2550XPB

Subject: ☐ ☐ Wheel hubs may show excessive wear after extensive use.

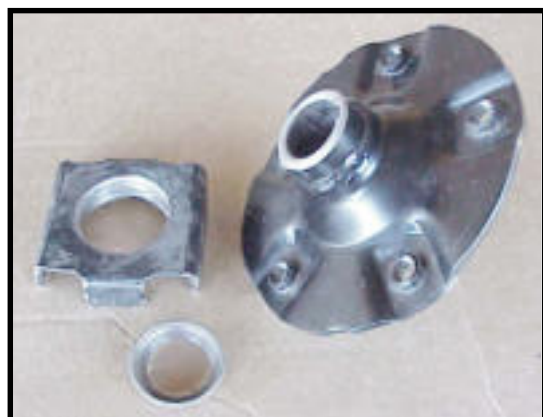
On specific automatic transaxle units, the keyway inside the wheel hub may become damaged due to an undersized 2" key and soft washers. There may be wear on the inside surface of the rear wheel hub, washers and axle flange brackets inboard of the GT wheel hub. This condition may develop after several hundred hours of extreme use.

Worn hub, bracket & washer

Remove the two plastic axle caps (if equipped), e-rings, and outside washers at the end of the transaxle shafts. Remove the rear wheel hub assembly, washers/ spacer, the 2" keys on both axles, and the two axle flange washers adjacent to transaxle.

Install kit # 532 18 06-96 in the order illustrated. Inspect the wheel hub for any cracks or wear. If the wheel hub is cracked or shows extensive wear, replace with part # 532 14 05-07.

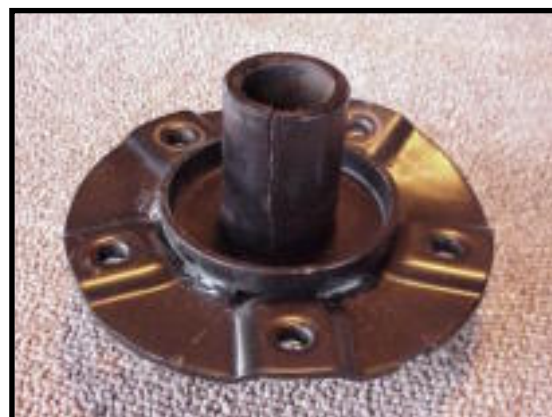
Cracked hub
