Supplement Sheet

Subject: Installation of Chipper-Shredder-Vac Chute Assembly 631-0083

PURPOSE: This supplement sheet provides instruction for the correct setup of the switch activation bracket on the 631-0083 CSV Chute Assembly.

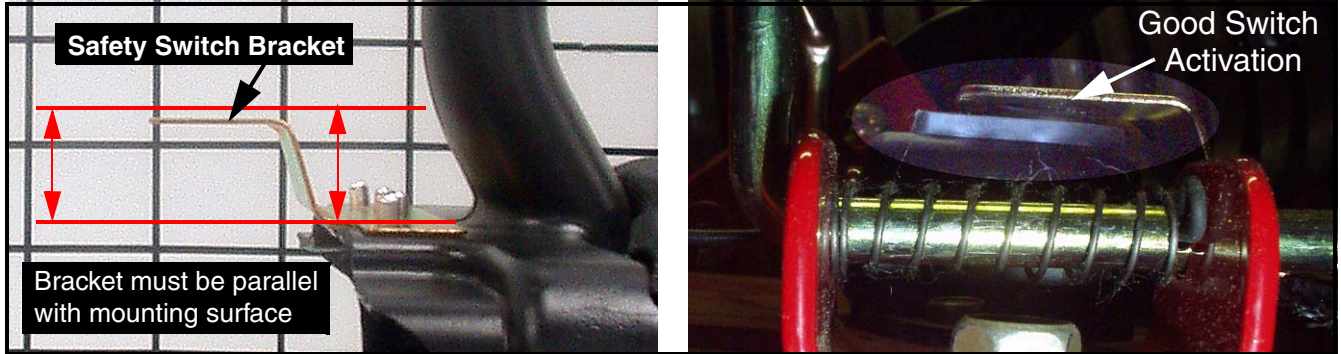
FIGURE 1

1. Inspect the Chute Assembly to ensure that the safety switch bracket is formed as shown in Figure 1.

3. To correct a bent safety switch bracket, use a pair of pliers and grip the safety switch bracket's tab as shown in Figure 3. While holding the chute assembly from moving, apply a bending moment in the direction necessary to bring the tab into the position shown in Figure 1.

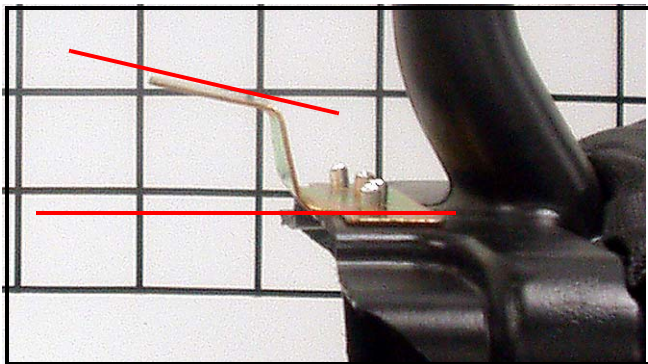
FIGURE 2A

2. If the safety switch bracket is bent as shown in Figure 2A, the safety switch may not be sufficiently depressed (activated) resulting in the engine not starting (i.e. ignition grounded).

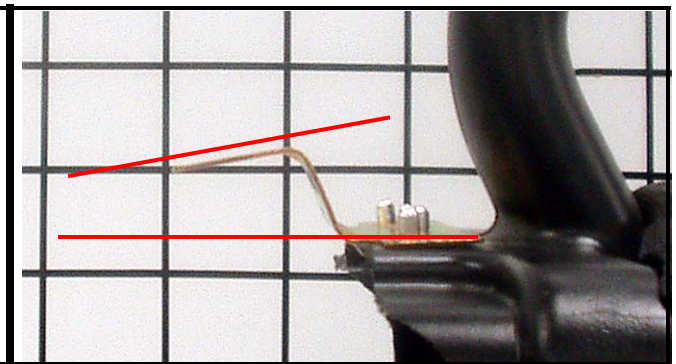
FIGURE 2B

If the safety switch bracket is bent as shown in Figure 2B, the chute assembly may not install properly also resulting in the engine not starting.
