SERVICE

11
		B0200049

SB, 325 HS 75, 325 HS 99, 326 HS 75, Collector, 2002-06

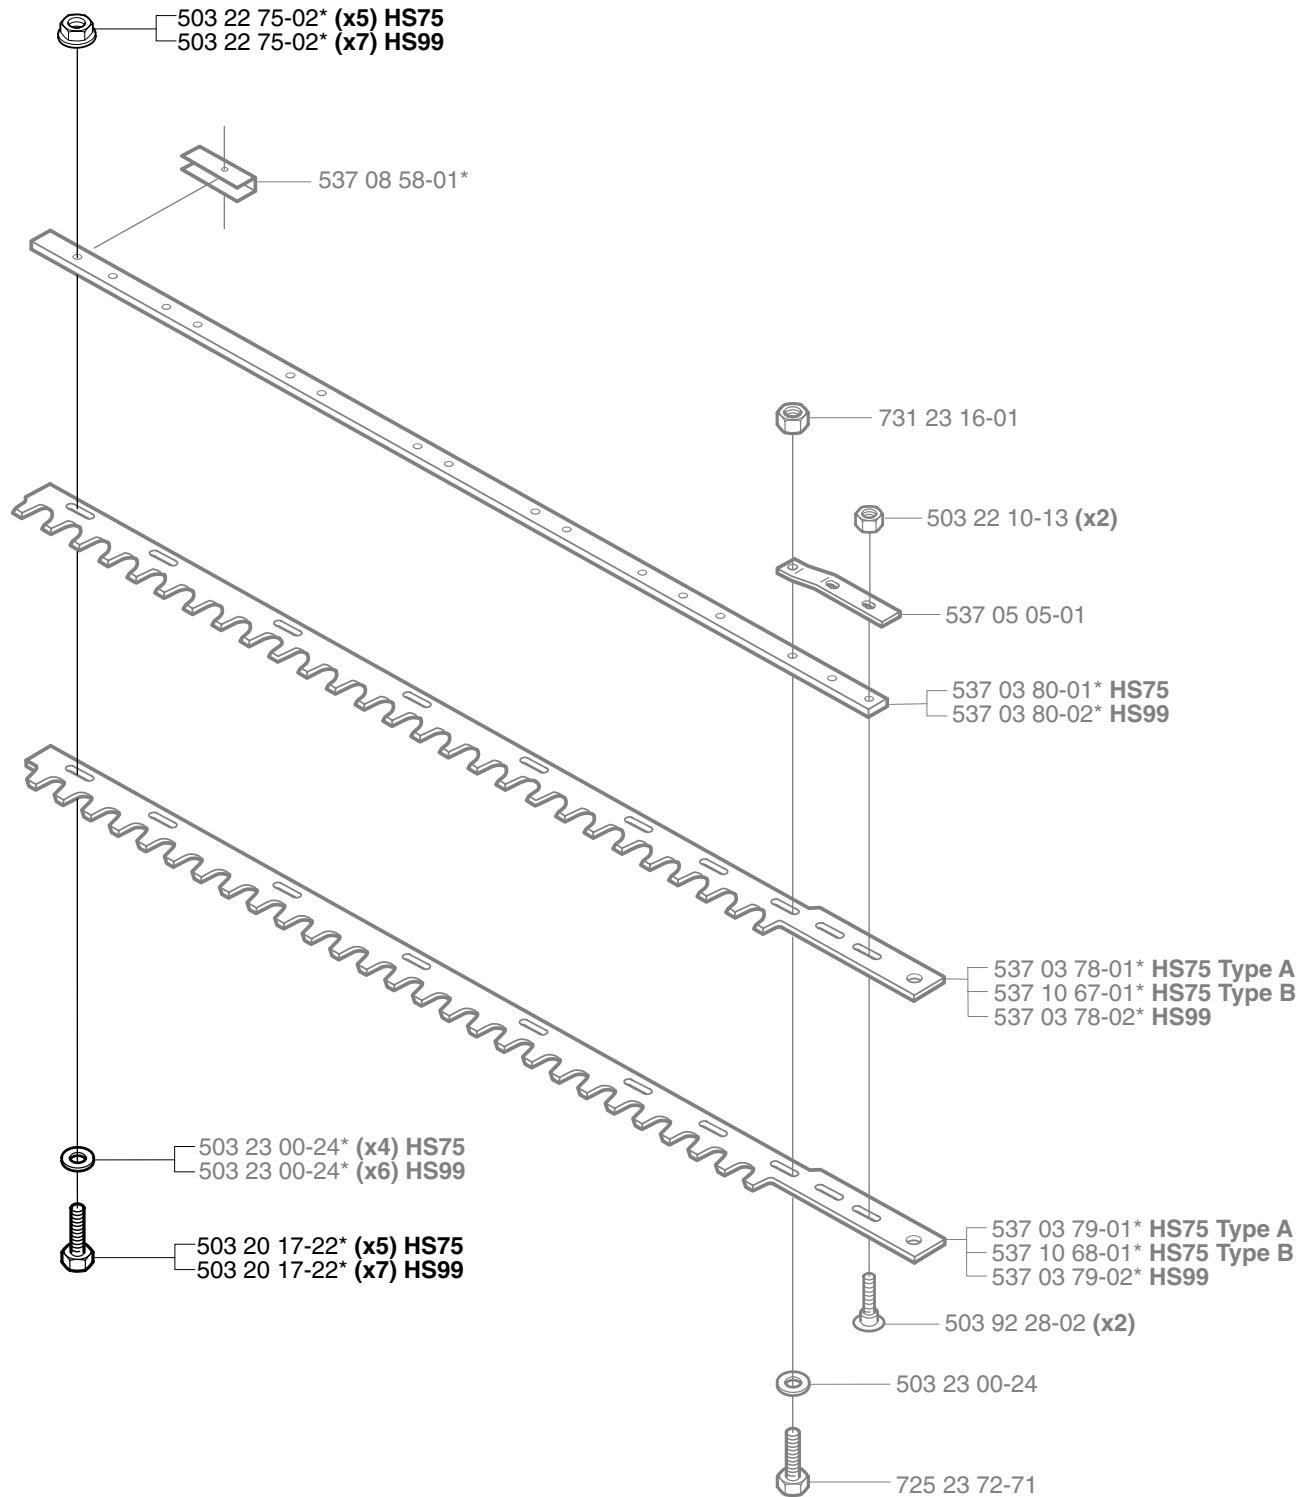
There have been cases where the collector has cracked as a result of starting the hedge trimmer incorrectly or vibration from the cutter bar. A number of modifications have been made to rectify this problem.

The front edge of the collector has been modified and it now has round mounting holes. The part number is unchanged.

The cutter bar has nuts with integral washers, and longer screws to allow the collector to be attached more securely.

The nuts with integral washers have a locking action that reduces the risk of them working loose as a result of vibration. The tightening torque during assembly has also been increased from 6 to 11 Nm.
