Product Safety Recall Bulletin

Bulletin No: 2006-6-01

Subject: Brake Disc and Brake Lever Assembly

2006 Prowler XT Models within the Vehicle Identification Range (VIN) of 4UF06MPV06T300001 - 4UF06MPV86T300781

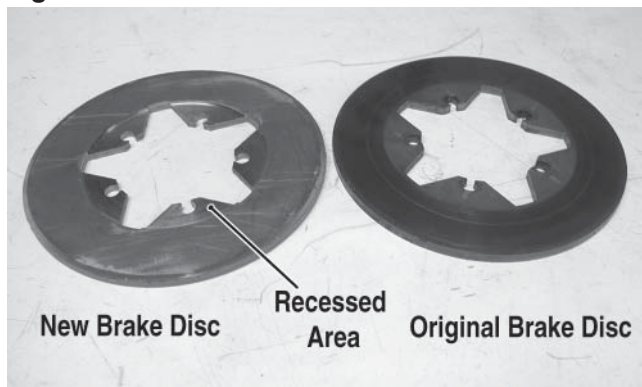
Fig. 1

The new brake disc will have a recessed (machined) area on the side facing the rear gear case. The new brake disc will also be secured with yellow shoulder screws contrasted to the original disc which is secured with black shoulder screws. See Fig. 1.

Condition #1: Brake Disc- In some instances, the rear disc may allow one of the brake pads to become misaligned, or in some cases, may be ejected from the floating caliper assembly. If this condition were to occur, it may lead to immediate or premature brake failure.

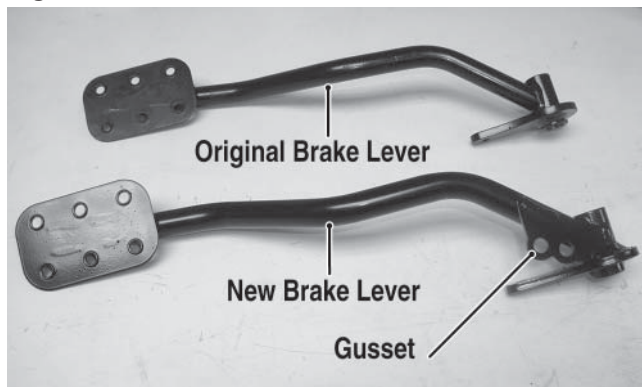
Fig. 2

The new brake lever will have a gusset welded to the backside of the upper section of the brake lever (next to the upper pivot tube). See Fig. 2.

Condition #2: Brake Lever Assembly- In some instances, the brake lever assembly may bend when subjected to a possible emergency load. If this condition were to occur, the bent brake lever assembly may limit the amount of brake lever movement limiting the braking ability.
