SERVICE

10
		X 91.139-26

MODEL 165 RX

DRIVE SHAFT TUBE

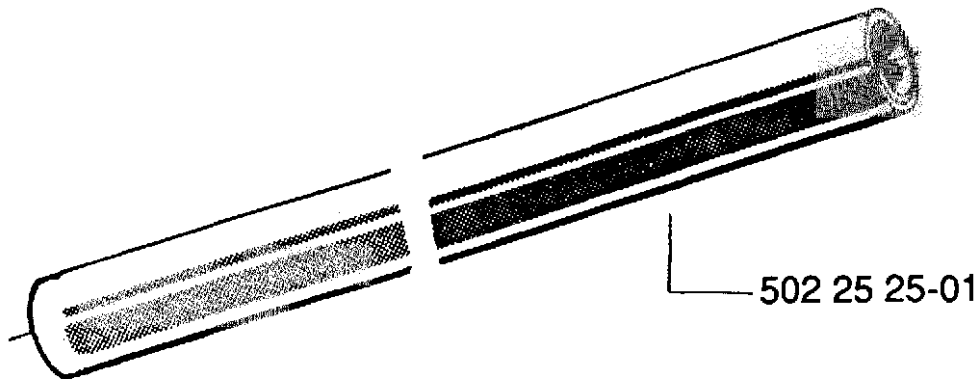
To reduce wear on the drive shaft tube bushings the following improvements have been made:

- Bushings have been made from a new material with better self-lubricating properties.
- When installing the bushings in the drive shaft tube the accuracy of fitting has been increased.

The drive shaft tube ref. no. 502 25 25-01 remains unchanged (fully interchangeable).

To allow easy identification of the improved drive shaft tube, those held as spare parts will be marked with red paint.

Introduced from serial no. 1090001.
