Models 61, 266, 268, 272, 254, 257, 262, 394

New oil tank ventilation tube

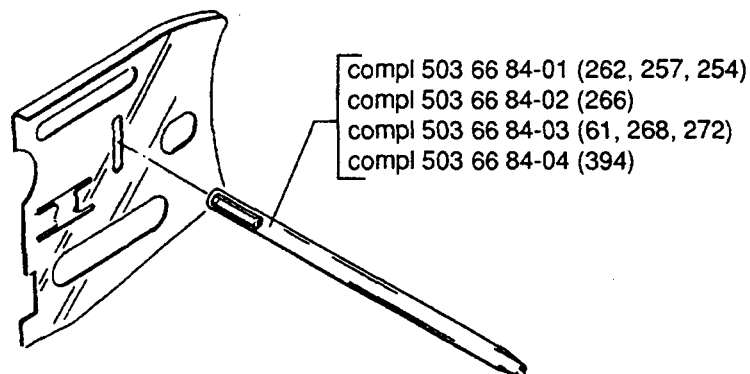
In order to improve the function and to prevent oil leakage, a new design is introduced. The change means that the spiral pin is now mounted inside the plastic tube and then pushed into the crankcase.

NOTE! The spiral pin included in the new design compl. is not the same pin as ref. no. 721 42 32-50.
