SERVICE

1
		X 94.142-26

Model 394

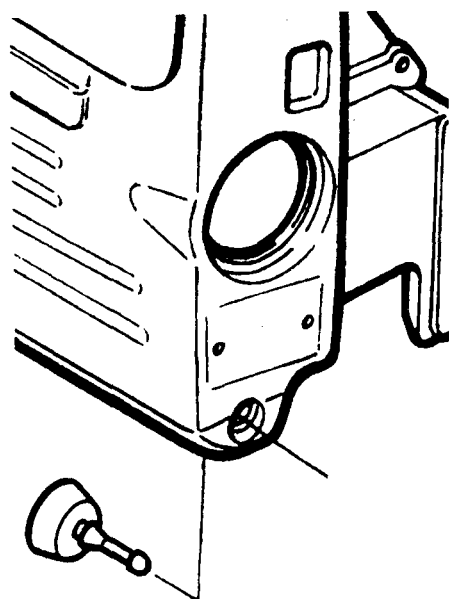
In order to receive an improved function, the front left rubber side support is made larger. This prevents the support from changing position in case the saw gets stuck.

NOTE! Only the front left rubber side support is replaced.

New Ref. No.	Description
503 74 30-01	Rubber side support

Introduced from serial number: 4020251
