<b>5</b>
X 94.023-26

## Model      Royal 43 S

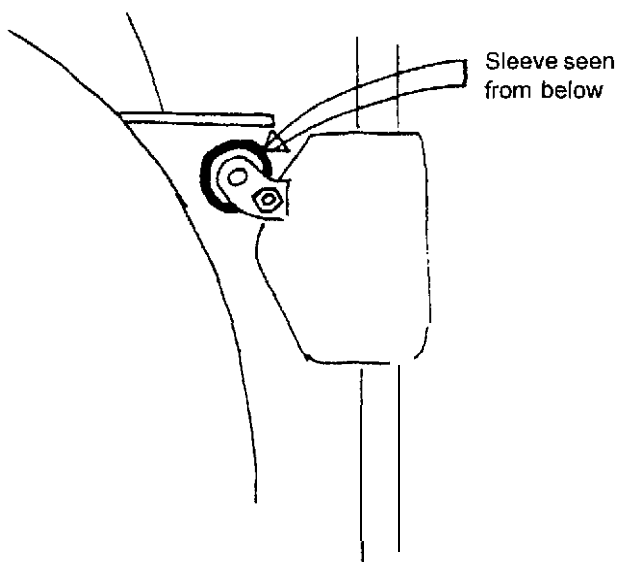
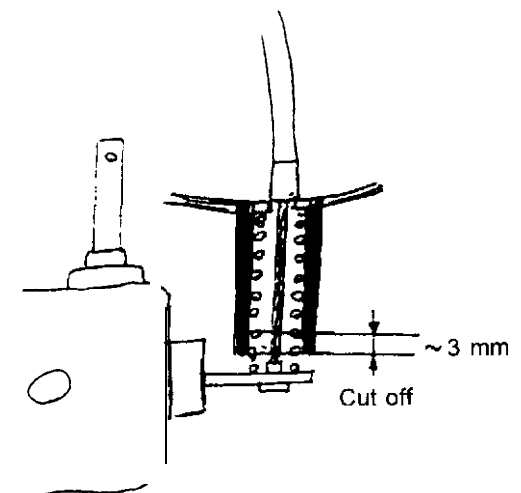
Some of the above named lawn mowers can lose their drive capacity due to the belt slipping. If this cannot be adjusted using the wire it can be due to adverse belt tolerances or the cutting deck. One way to increase the tensioning possibilities of the belt is to remove material from the sleeve around the gearbox's tensioning spring.

Proceed as follows:

- Empty the oil and fuel.
- Remove the belt and belt pulley.
- Loosen the wire from the gearbox and remove the spring.
- Remove the rear wheel suspension (it is best to remove the bearing cover and then fold back the rear wheel suspension to avoid replacing the start lock washer on the height adjustment stay).
- Cut approx. 3 cm off the sleeve (chisel, sharp knife or any other tool can be used).

Reassemble
